**REPORT NUMBER GSDR 805A**  
**NIGHT VISION SIGHT, INFRARED**  
**AN/TAS-3**  
**(U)**

FINAL REPORT

Contract No. DAAK02-72-C-0156

GOVERNMENT SYSTEMS DIVISION  
PHILIPS AUDIO VIDEO SYSTEMS CORP.  
91 MCKEE DRIVE, MAHWAH, N. J. 07430  
TEL: 201-529-3800 TWX: 710-988-5348  
A NORTH AMERICAN PHILIPS COMPANY

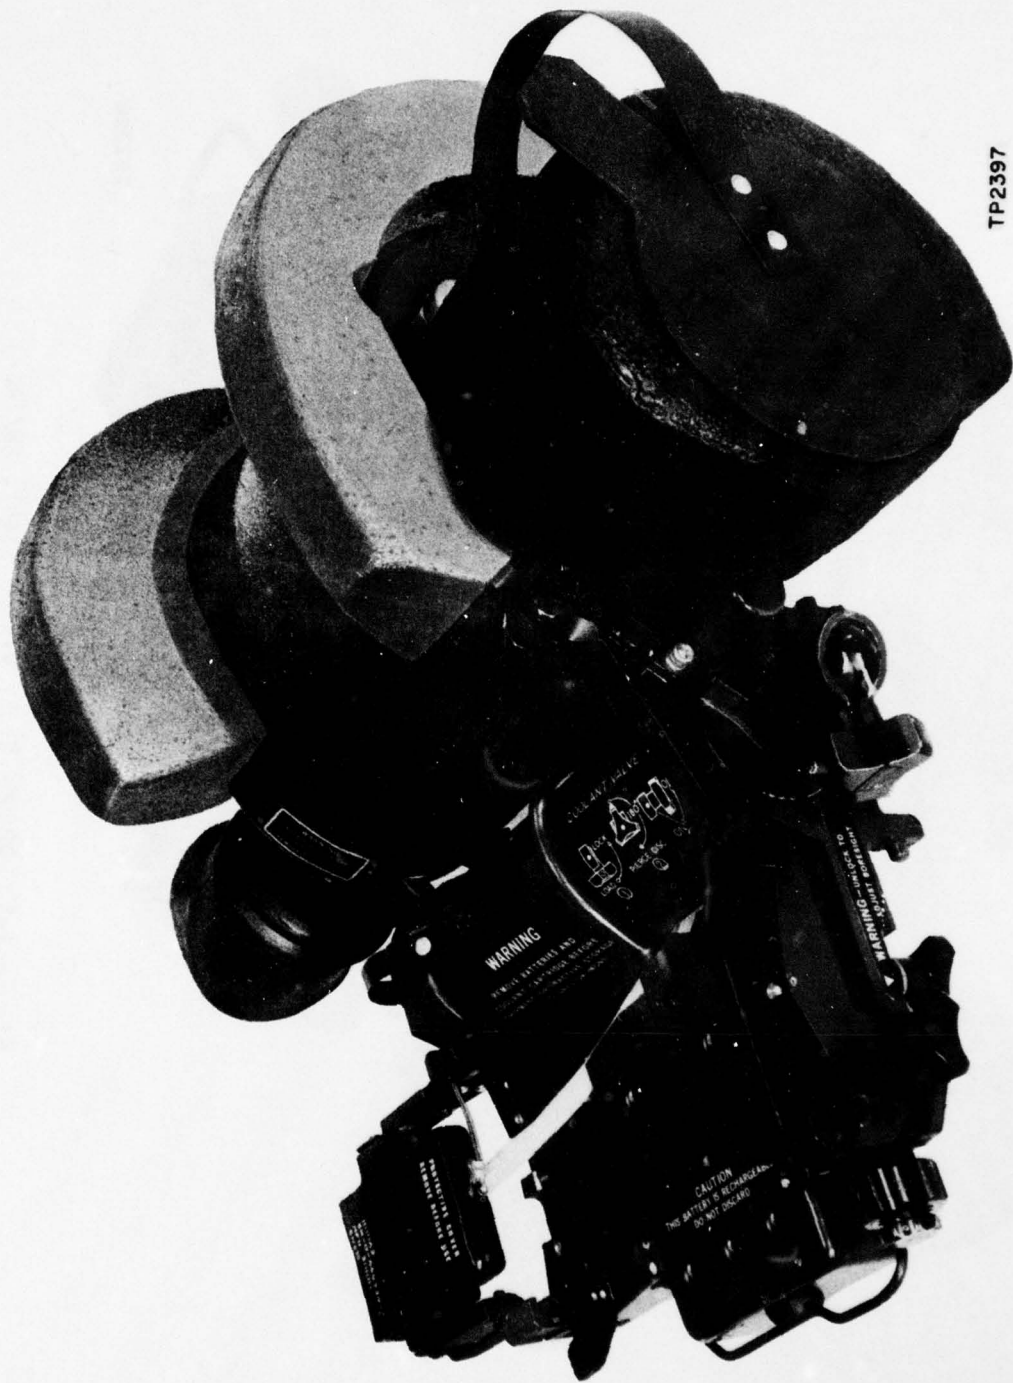
TP2397

Figure 1-2. DRAGON Night Vision Sight AN/TAS-3  
Engineering Development Model

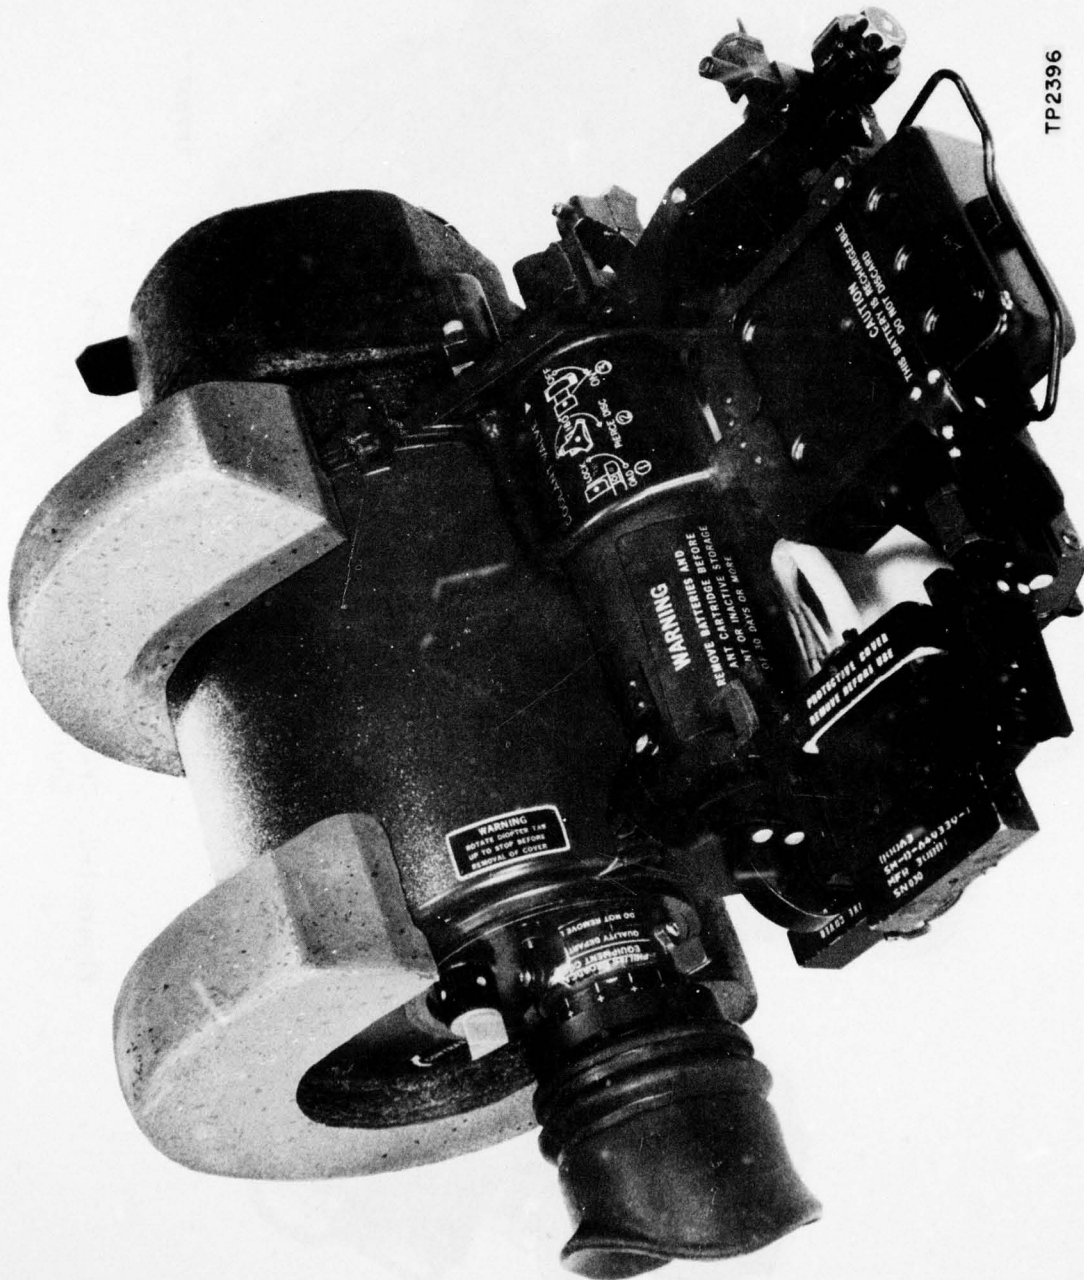
TP2396

Figure 1-3. DRAGON Night Vision Sight, AN/TAS-3 Engineering Development Model

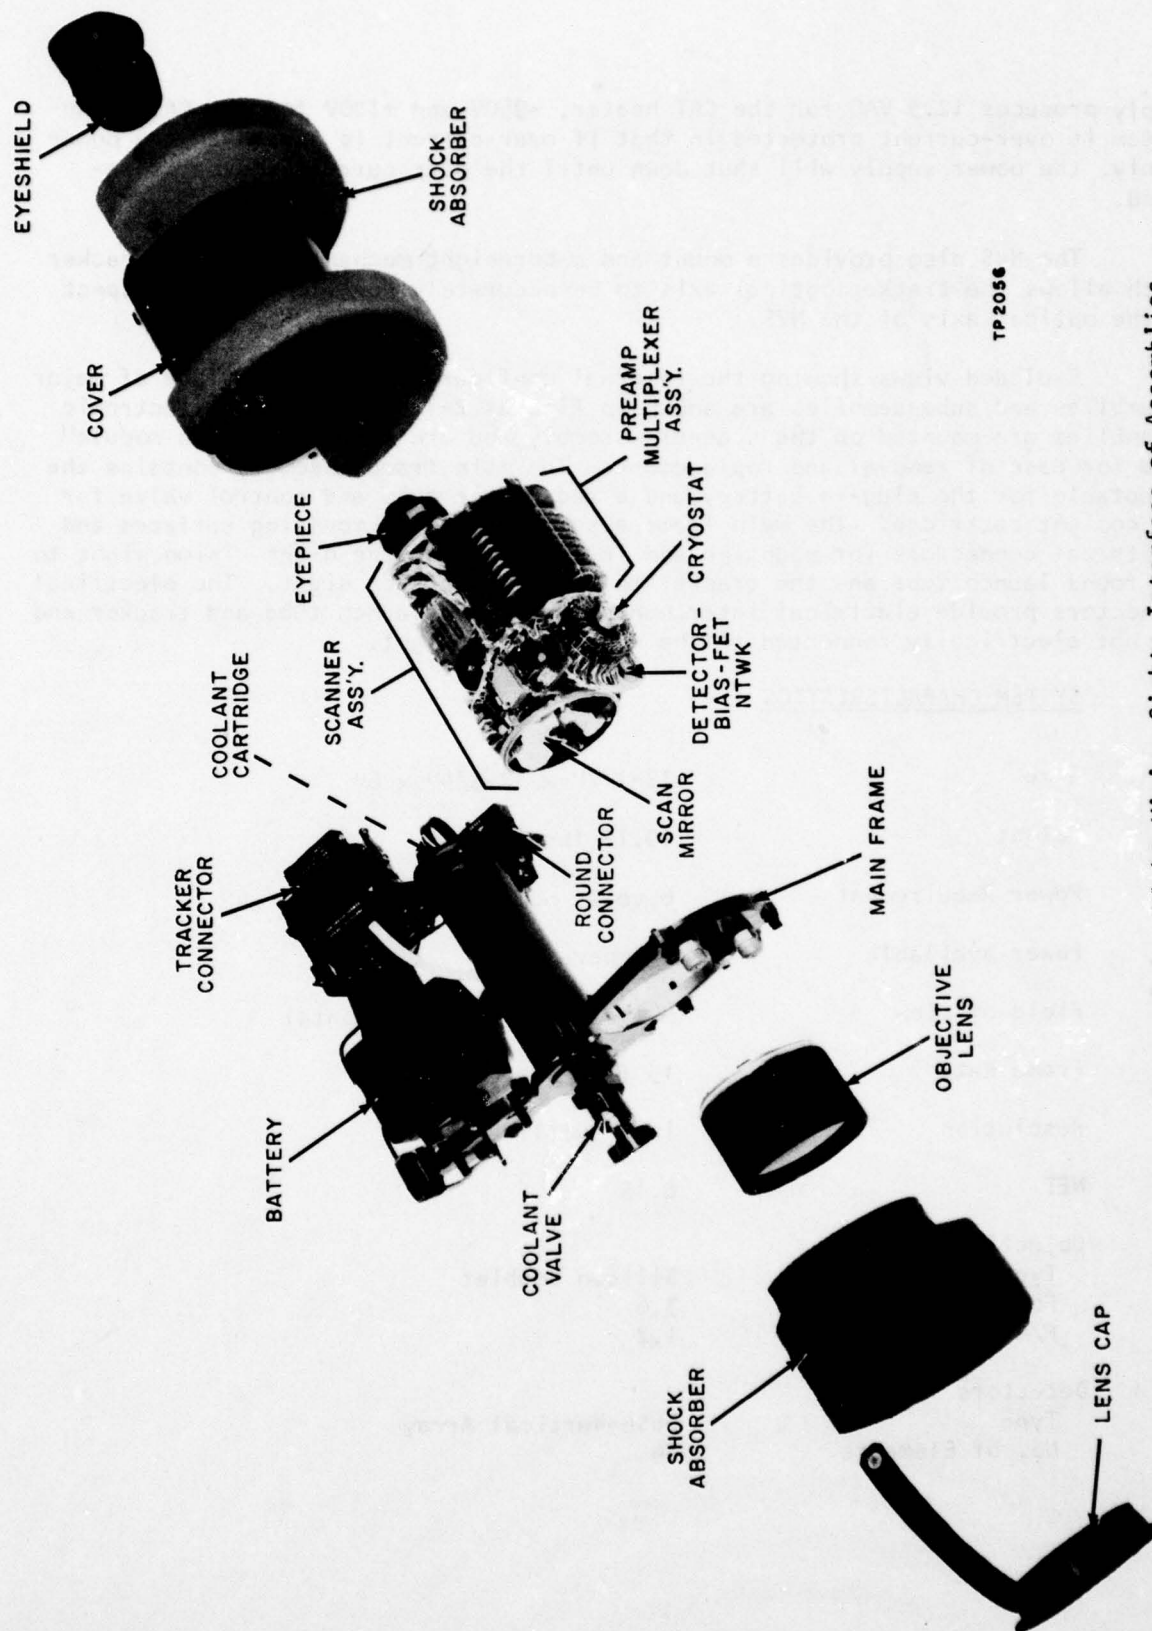
TP 2056

Figure 2-1. Night Vision Sight; Interface of Assemblies

Exploded views showing the internal configuration and interface of major assemblies and subassemblies are shown in Figures 2-1 and 2-2. All electronic assemblies are mounted on the scanner assembly and are of the "plug-in module" type for ease of removal and replacement. The main frame assembly contains the receptacle for the plug-in battery and a receptacle tube and control valve for the coolant cartridge. The main frame also provides the mounting surfaces and electrical connectors for mounting and interconnecting the night vision sight to the round launch tube and the tracker to the night vision sight. The electrical connectors provide electrical interconnection of the launch tube and tracker and are not electrically connected to the night vision sight.

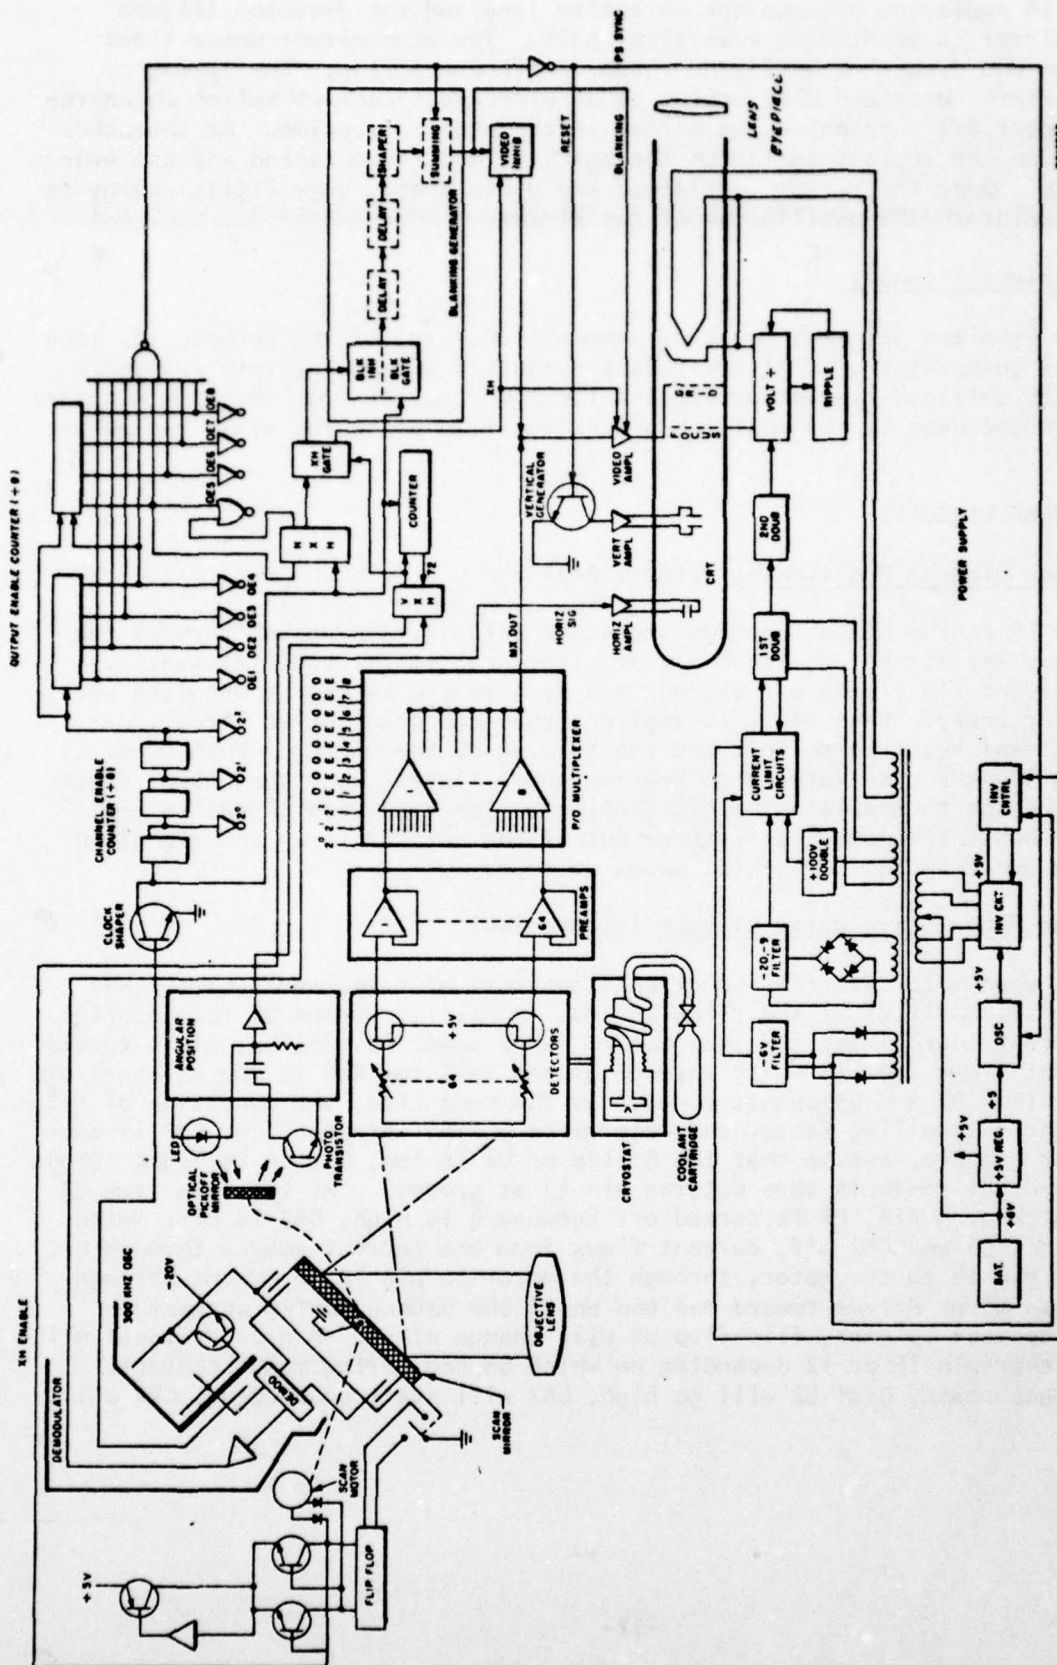
Figure 2-3 System Block Diagram  
-11-

ing beam of IR radiation between the objective lens and the detector (Figure 2-3). The mirror is mounted on a vertical axis. The scan mirror motor turns the mirror in one direction until the mirror strikes a spring. The spring bounces the mirror back and also serves as an electrical contact switch which reverses the motor drive to drive the mirror in the other direction. At the other end of rotation the contact spring on the opposite end is contacted and the process repeated. Once the mirror is started and up to speed, very little energy is required to maintain the oscillation of the mirror.

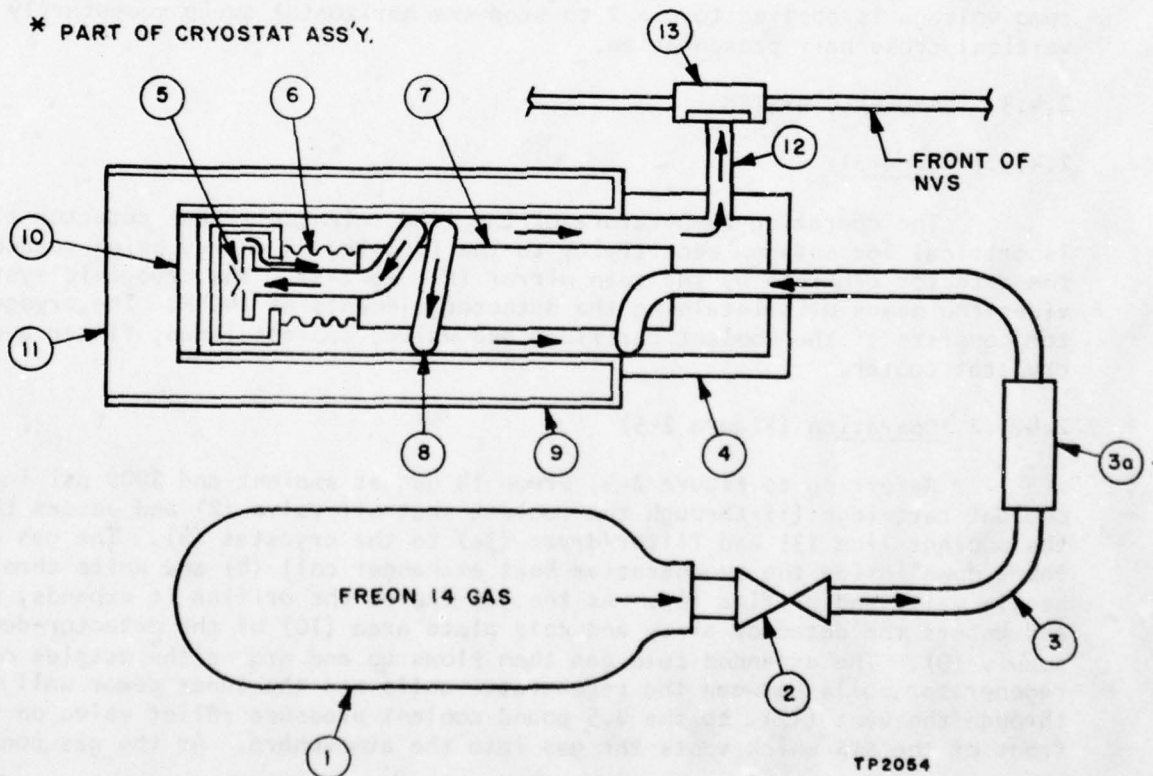
TP2054

Figure 2-5. Cryogenic System

The cartridge is a 7 cubic inch cylinder capable of storing Freon 14 gas at 3200 psig. This rechargeable cartridge will supply enough coolant gas to operate the Night Vision Sight continuously for over two hours. The cartridge may be safely removed from the NVS after the seal has been ruptured while still containing coolant under pressure.

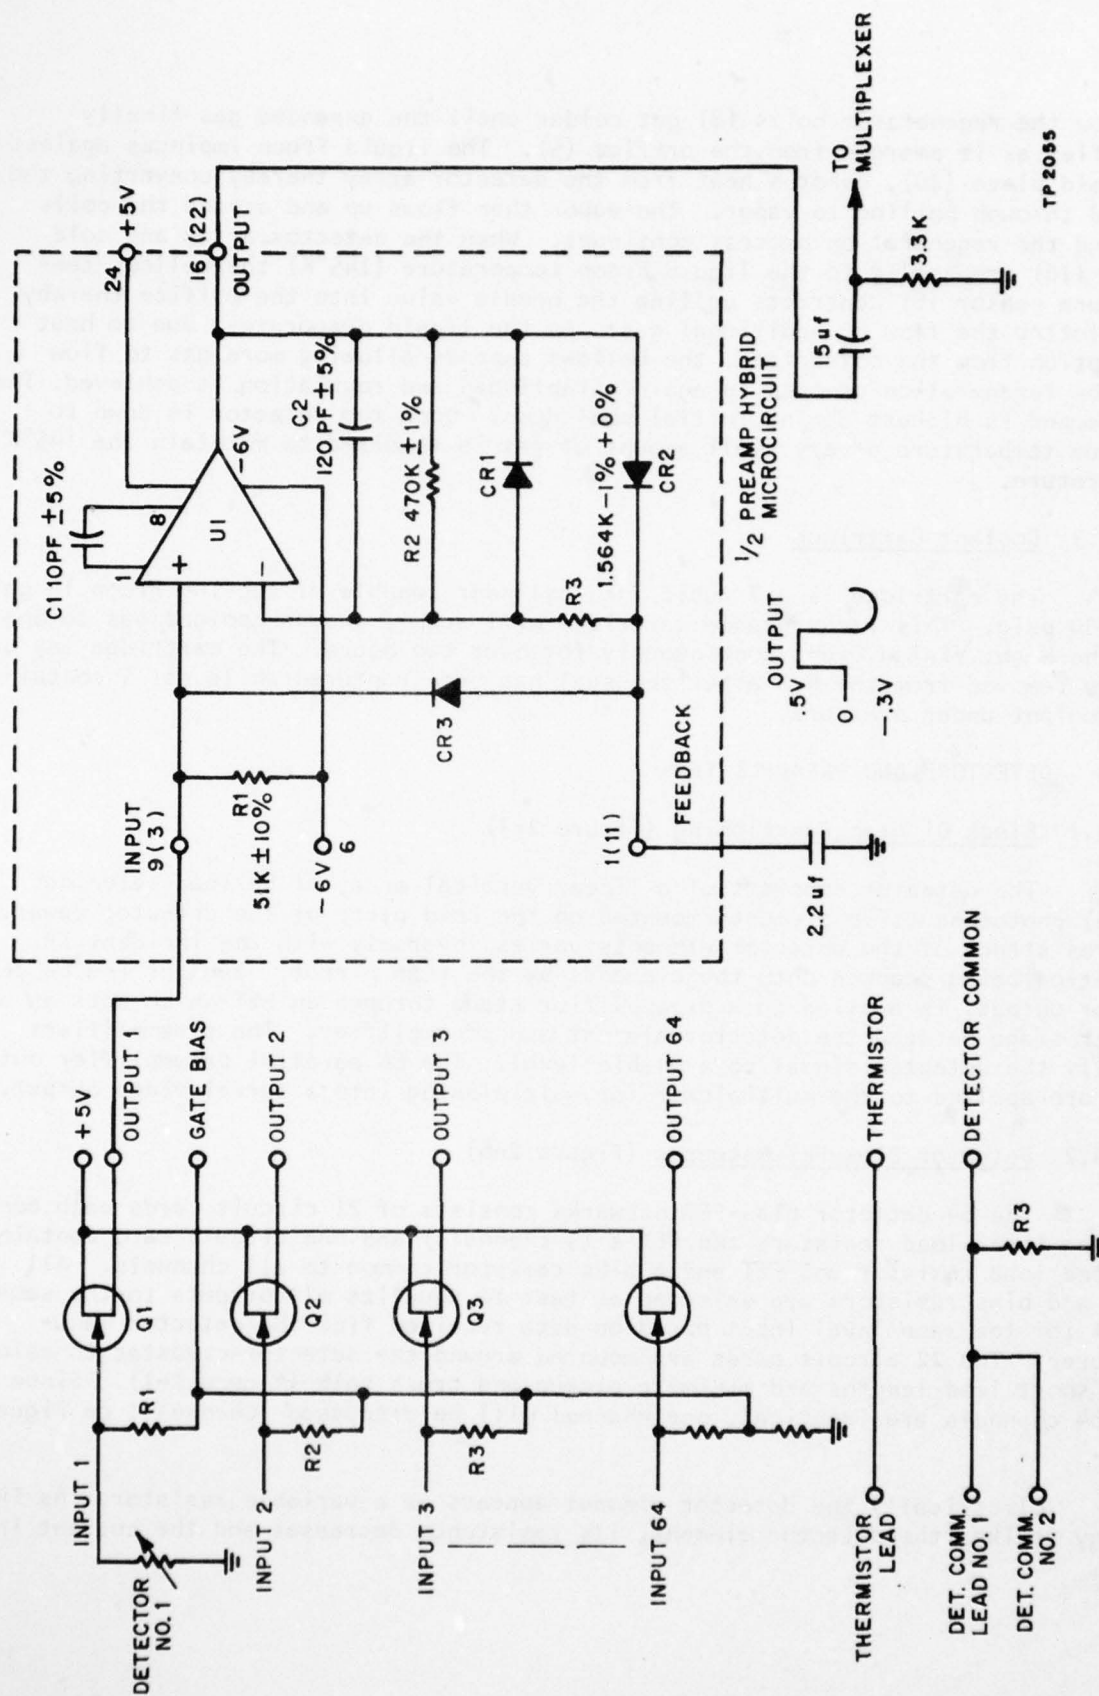
Figure 2-6. Detector/Preamplifier Simplified Schematic Diagram

The 64 detector bias-FET networks consists of 21 circuit cards each containing three load resistors and FET's (3 channels) and one circuit card containing one load resistor and FET and a bias resistor common to all channels. All load and bias resistors are selected at test to equalize all outputs to the same level for the same level input based on data received from the detector manufacturer. The 22 circuit cards are mounted around the detector-cryostat to maintain short lead lengths and minimize pickup and cross talk (Figure 2-1). Since all 64 channels are identical, one channel will be discussed (Channel 1 on Figure 2-6).

Electrically the detector element appears as a variable resistor. As IR energy strikes the detector element, its resistance decreases and the current in-

creases. The hotter the target the greater the current. Thus the detector is a current signal. The voltage developed across the detector load resistor is fed to the FET. The FET input impedance is extremely high (megohms). All current through load resistor R1 goes through the FET which acts as a buffer stage preventing loading of the detector by the preamplifier circuit that follows. The source of the FET is connected through R1 in the preamplifier microcircuits to -6V (pin 6). Although R1 is in the preamplifier microcircuit it is actually part of the FET circuit.

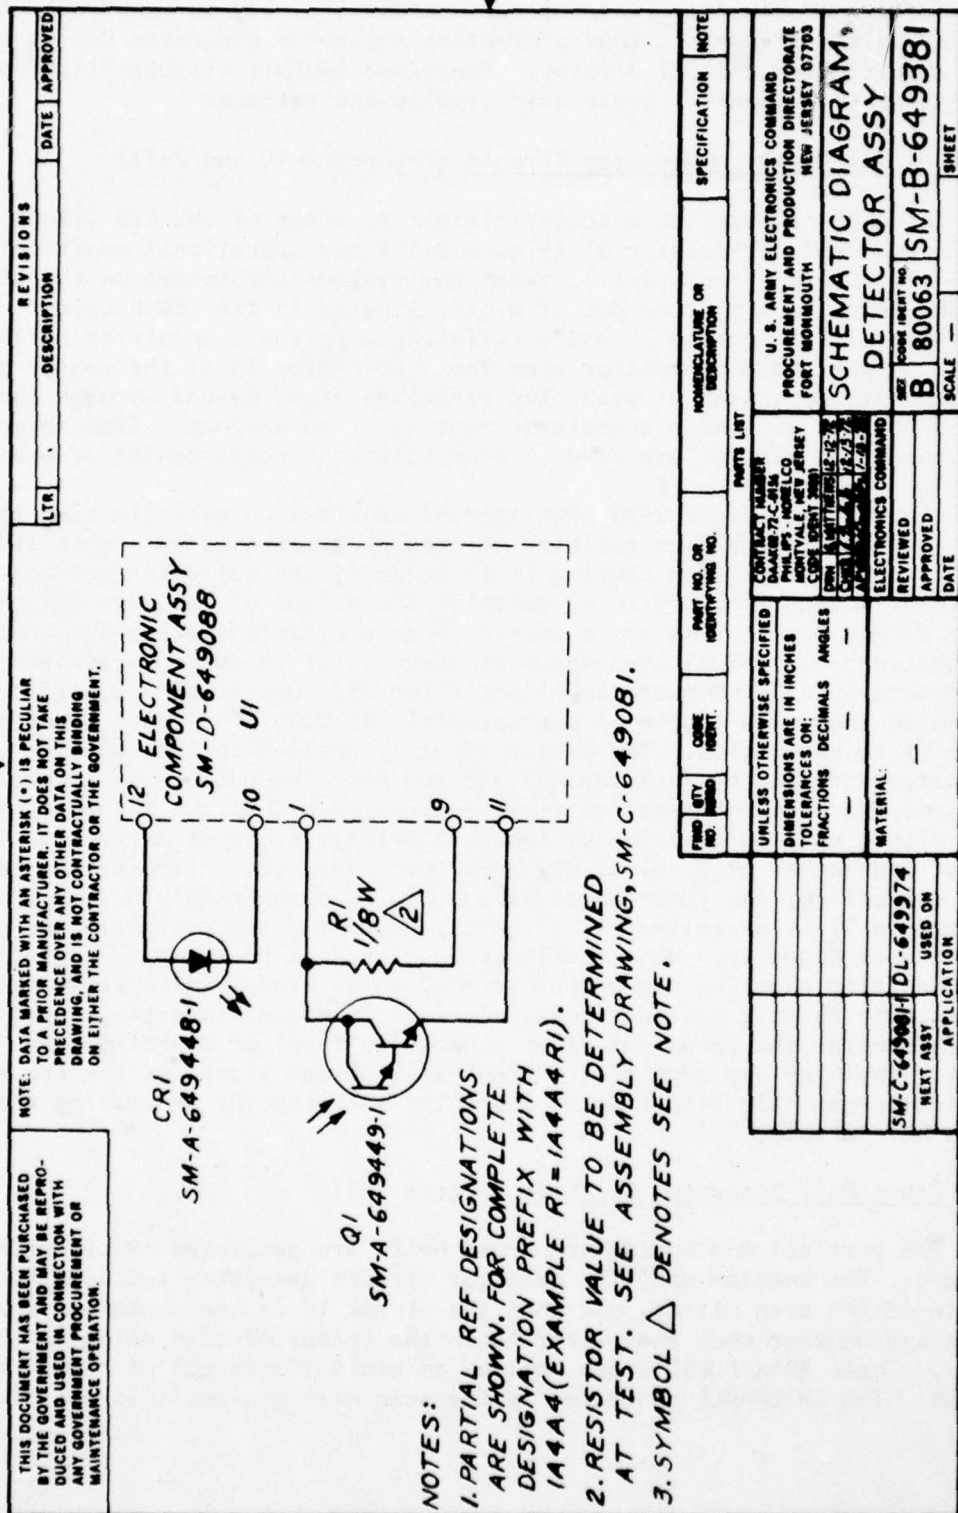
Figure 2-10

The angular position detector circuit consists of the LED (light emitting diode) CR1 and photo transistor Q1 (Figure 2-10) and operational amplifier U1 and associated circuitry (Figure 2-11). When the systems are turned on the LED produces light which is projected out of a slit located in the LED housing. The optical pickoff mirror mounted on and oscillating with the scan mirror reflects the light back to the photo transistor when the scan mirror is at the center of the scan cycle. At the center of scan, the reflected light passes through the same "slit" and strikes the photo transistor causing it to conduct. (The reflected light does not enter the slot at any other mirror position except center of scan cycle.)

Referring to Figure 2-10, resistor R1 provides current limiting for the LED. Resistor R2 is the bias resistor for the photo transistor. When light strikes the photo transistor causing it to conduct, the collector voltage goes in a negative direction (from +4 to +2 volts). The values of the coupling network capacitor C1 and resistor R3 are chosen to form a differentiating network. The spike produced by C1 and R3 when the photo transistor conducts is applied to the inverting side (pin 2) of operational amplifier U1. Operational amplifier U1 is operated open loop with a gain of approximately 25,000. The spike produced by C1-R3 drives U1 to saturation. The output of U1 is applied to the top of a voltage divider network formed by resistors R7, R8 and R9. The output is clamped by diodes CR1 and CR2 with the negative limit controlled by CR1 and the positive limit by CR2. With a small signal in, U1 tends to drive the output extremely high. As the output approaches +3.7 volts, CR2 goes into conduction clamping the output. With CR2 conducting, the junction of R8 and R9 is approximately 0.7 volt and the OUTPUT (at pin 4) is approximately +3 volts. When the input signal goes positive, the output goes negative. When the junction of R7 and R8 reaches -0.7 volt, CR1 starts conducting clamping the output at -0.7 volt. To minimize false triggering of U1, resistor R6 puts a slight negative level on the noninverting input (pin 3) of U1. This holds the output of U1 at a negative level of approximately -0.5 to -0.7 volt. The trailing edge of the SCAN PULSE output signal is used to trigger the vertical cross hair flip-flop to start the sequence for generating the vertical cross hair display.

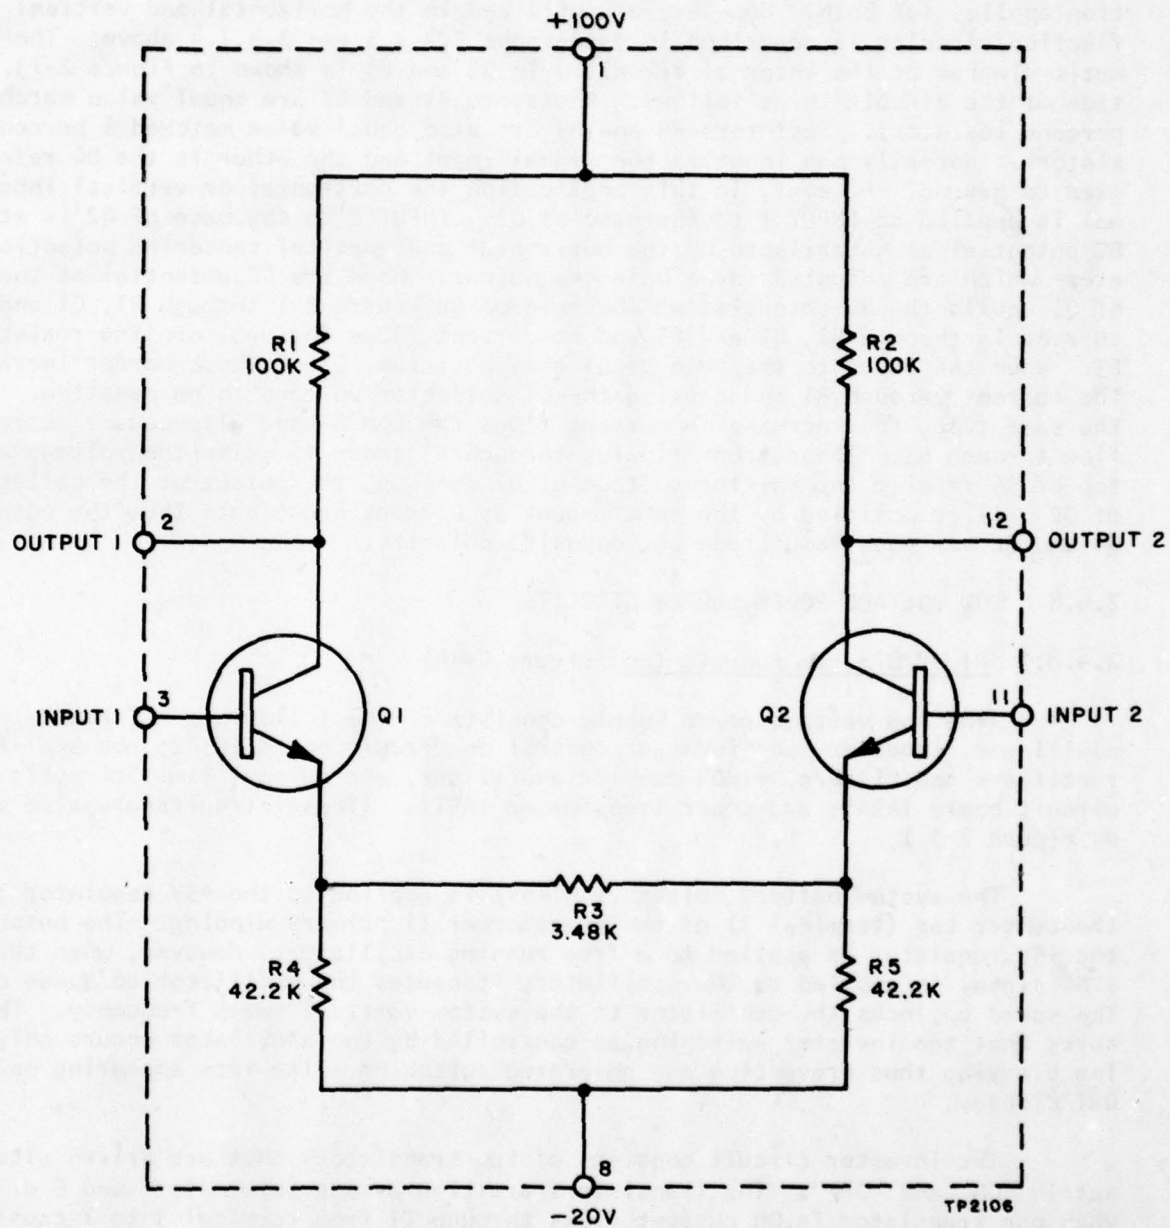
Figure 2-13. Hybrid Differential Amplifier Schematic Diagram

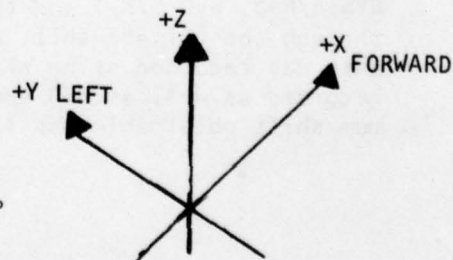
1. Boresight Tracker to NVS using BVD
2. Push against trigger guard of Tracker 15° off vertical down and rear with 100 lbs. Tracker XH moved up approximately 1/12 in and stayed.

3. Pull on Tracker trigger guard in -y direction with 50 lbs. Tracker XH moved right less than 1/12 mr and returned.
4. Push in +y direction with 50 lbs. No detectable movement.
5. Push in -z direction with 100 lbs. Tracker XH moved down less than 1/12 mr and returned.
6. Push in -x direction with 100 lbs. Tracker XH moved left approximately 1/12 mr and stayed.

At this point the Tracker XH was up and left about 1/12 mr. The Tracker was re-boresighted to the NVS to 0 - 0.

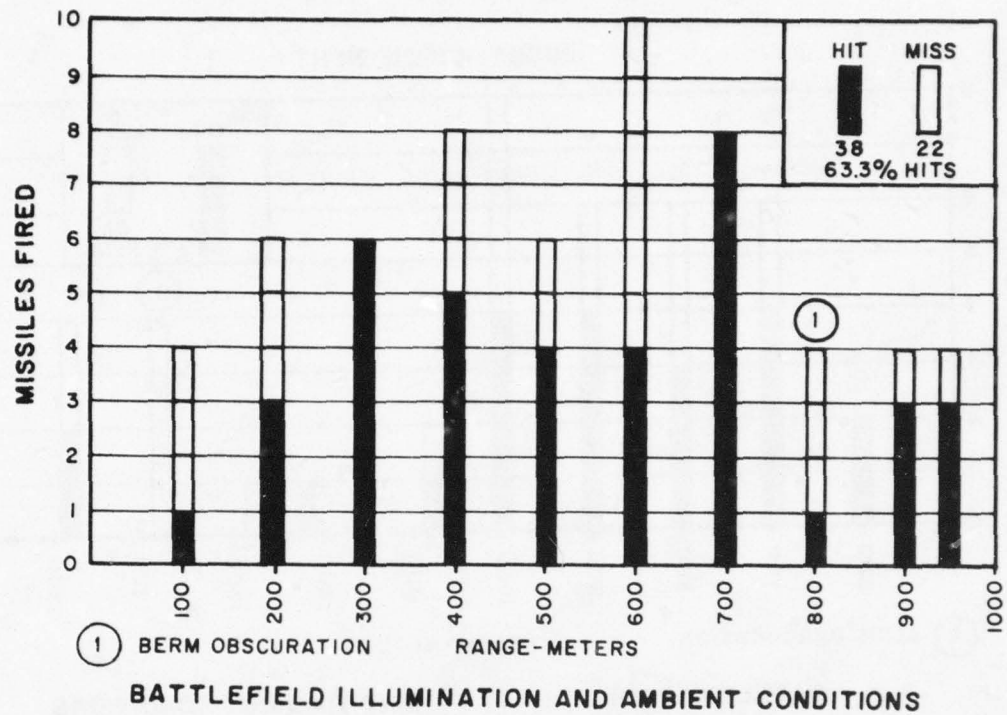
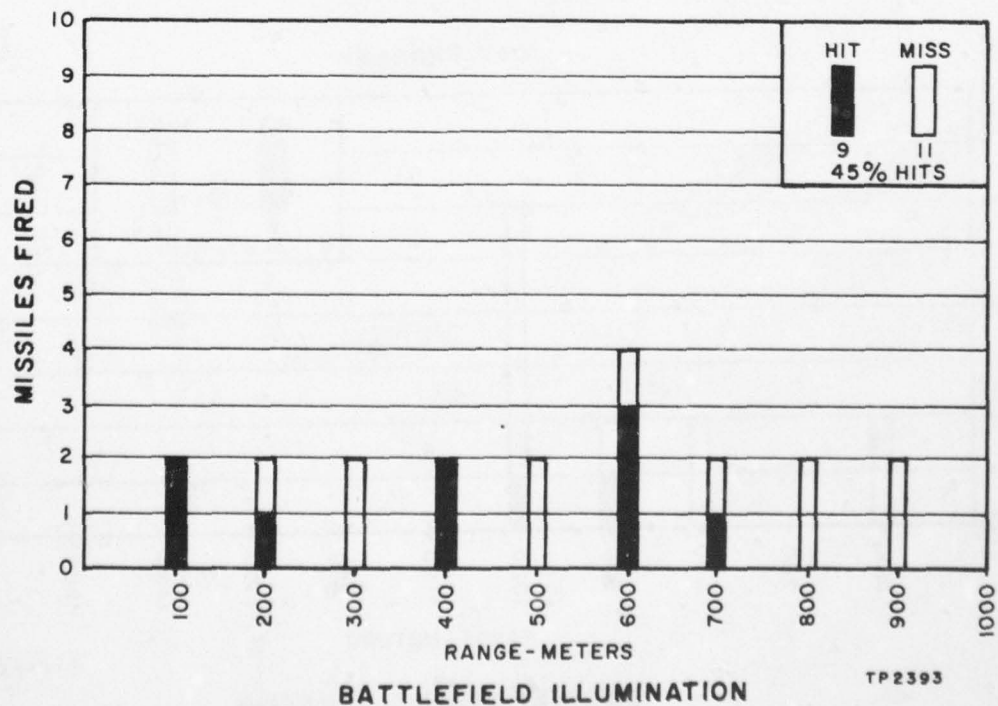
Figure 4-1

# DRAGON GUIDED MISSILE FLIGHT OT II

## NIGHT VISION SIGHT

## DAY TRACKER

Field Tests - Field tests commenced on 15 April and ended on 4 May with the last TOW firings. A typical week consisted of two days of detection, recognition, and survivability exercises, and two to three days of DRAGON and TOW missile firings. A graphic presentation of the firing results is shown in Figures 4-1 and 4-2. It is to be noted that the hit record at 800 meters with the DRAGON and at 1,375 meters with the TOW is not consistent with the weapon performance at adjacent ranges. A discussion with our field representative brought out the fact that the terrain at these two particular ranges was very undulating and that the ETT would be partially obscured for much of its run.

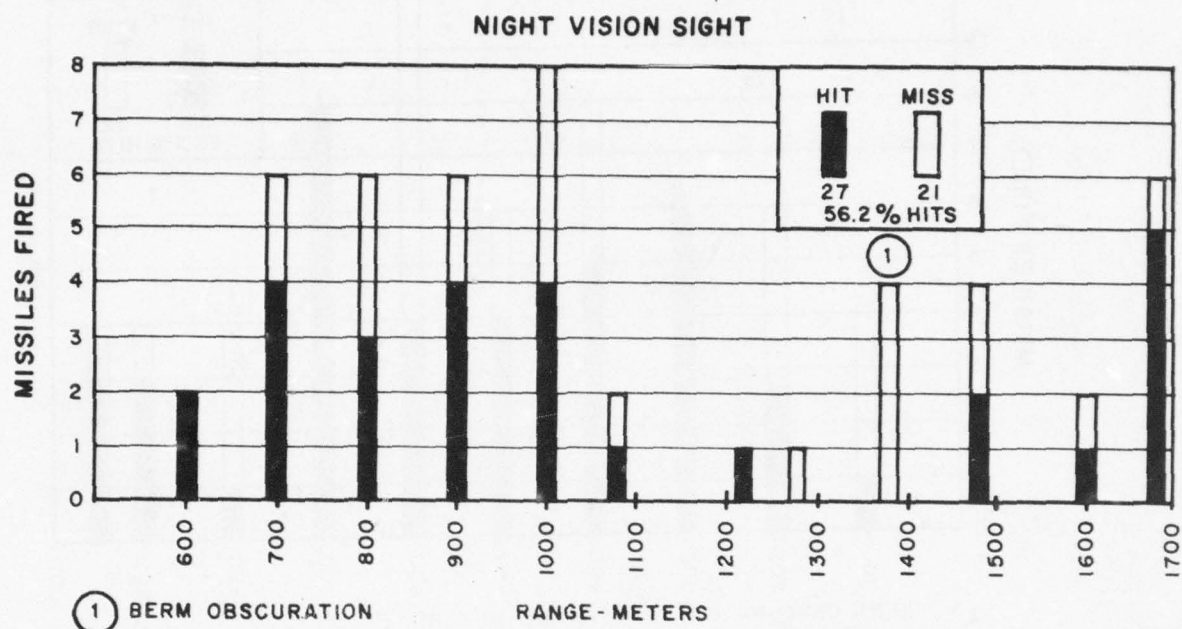
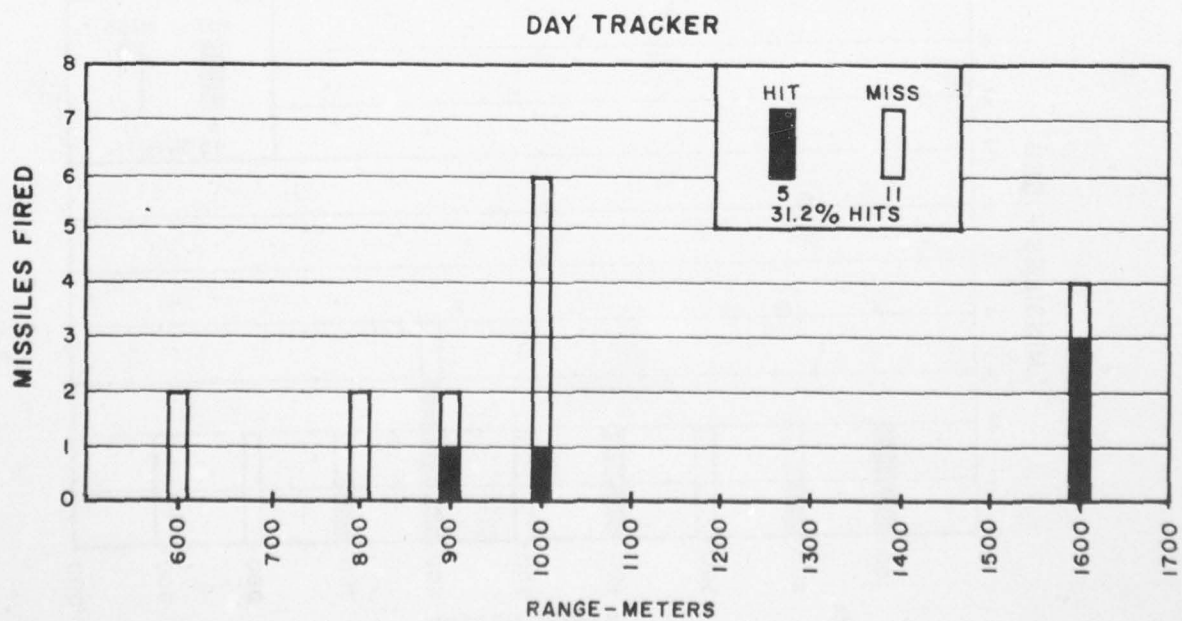
# TOW GUIDED MISSILE FLIGHTS - OT II

BATTLEFIELD ILLUMINATION AND AMBIENT CONDITIONS

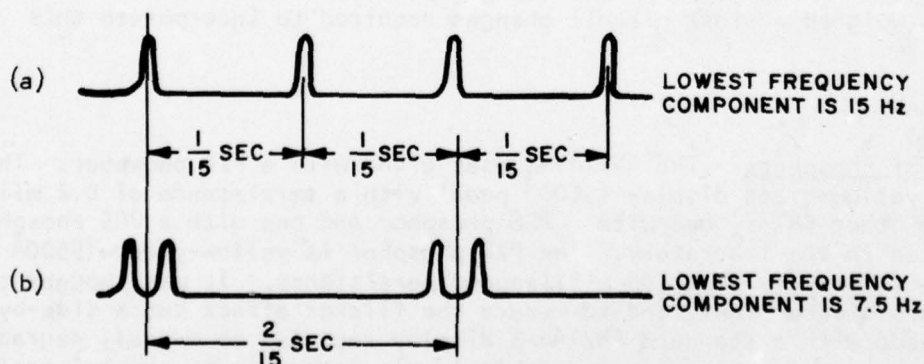
Edge flicker is caused by another effect. This may be explained by considering first a target in the exact center of the field of view and secondly, a target near the edge of the field of view. With the target in the center, the video waveform would appear as shown in (a) and with the target near the edge as in (b).

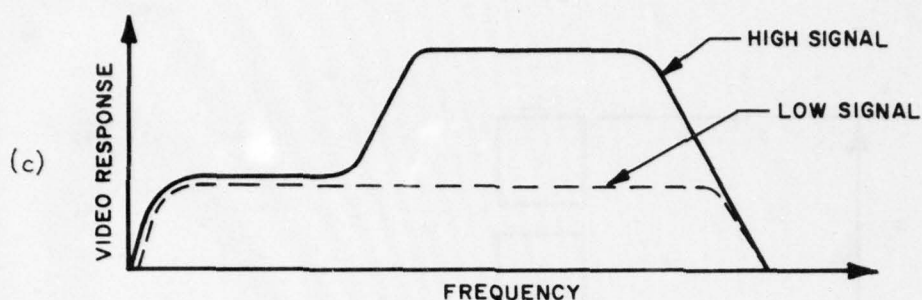
New signal processing techniques are being investigated on the Common Modules Program that appear to have application to the flicker, recovery and image quality problems of the DNS. Specifically, a non linear technique which produces a video response such as is shown in (c) below.

For weak video signals, the frequency response is extended to very low frequencies and thus will produce nearly identical frames from right to left and from left to right. For very bright extended targets, the video bandpass is reduced in the low frequency end. This helps to improve the recovery. The expected benefit of this technique is that the normal background which contains relatively weak video signals will be seen at the frame rate of the scanner and with less fatigue producing flicker. Strong target visibility will possibly be enhanced since the flicker frequency will be one half that of the scanner.

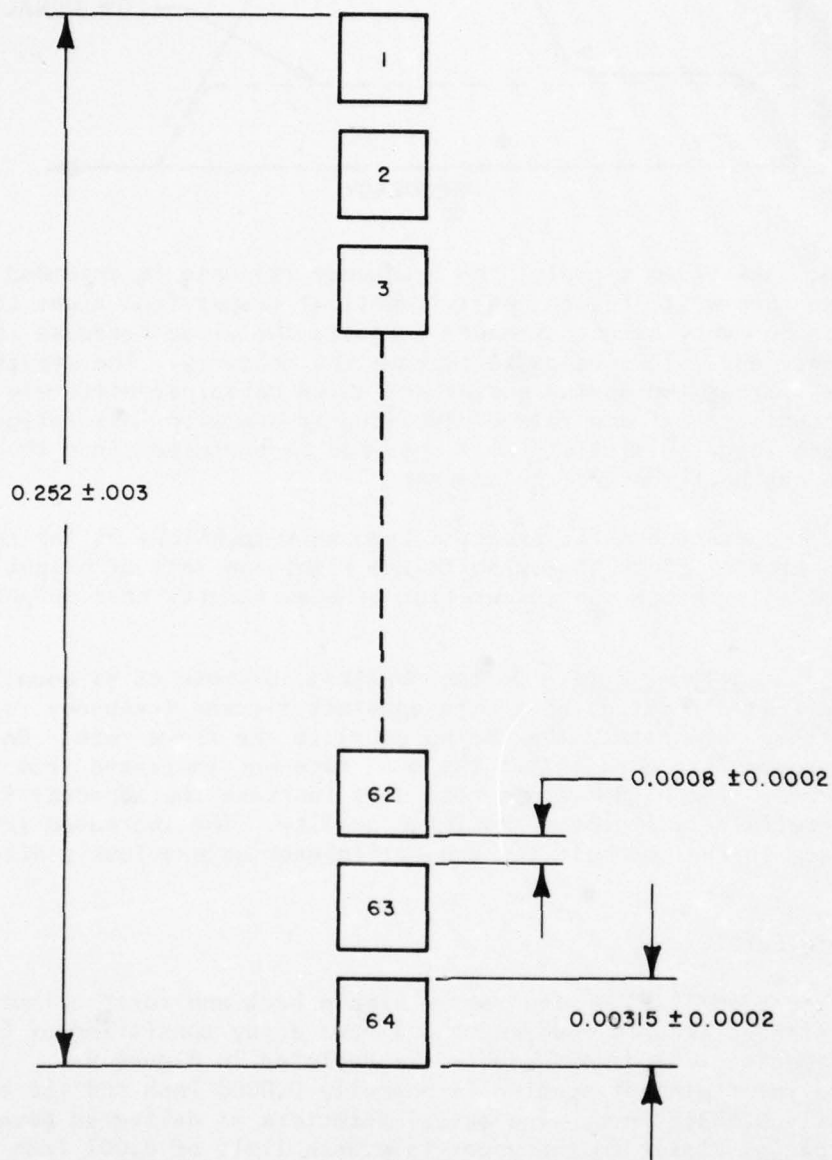
TP 2059

Figure 9-1. NVS Detector Array

The present AN/TAS-3 design uses a simple back and forth azimuth scan motion. The scanned area is covered by a linear array consisting of 64 nearly contiguous elements. The array geometry is depicted in Figure 9-1. It will be noted that the inter-element spacing is normally 0.0008 inch and the element size is normally 0.00315 inch. The actual detectors as delivered have an average element spacing closer to the upper tolerance limit of 0.001 inch and an average element size closer to the lower tolerance limit of 0.003 inch. There exists therefore a gap of roughly 33 percent in the scanned area coverage (not counting optics spot blurring).

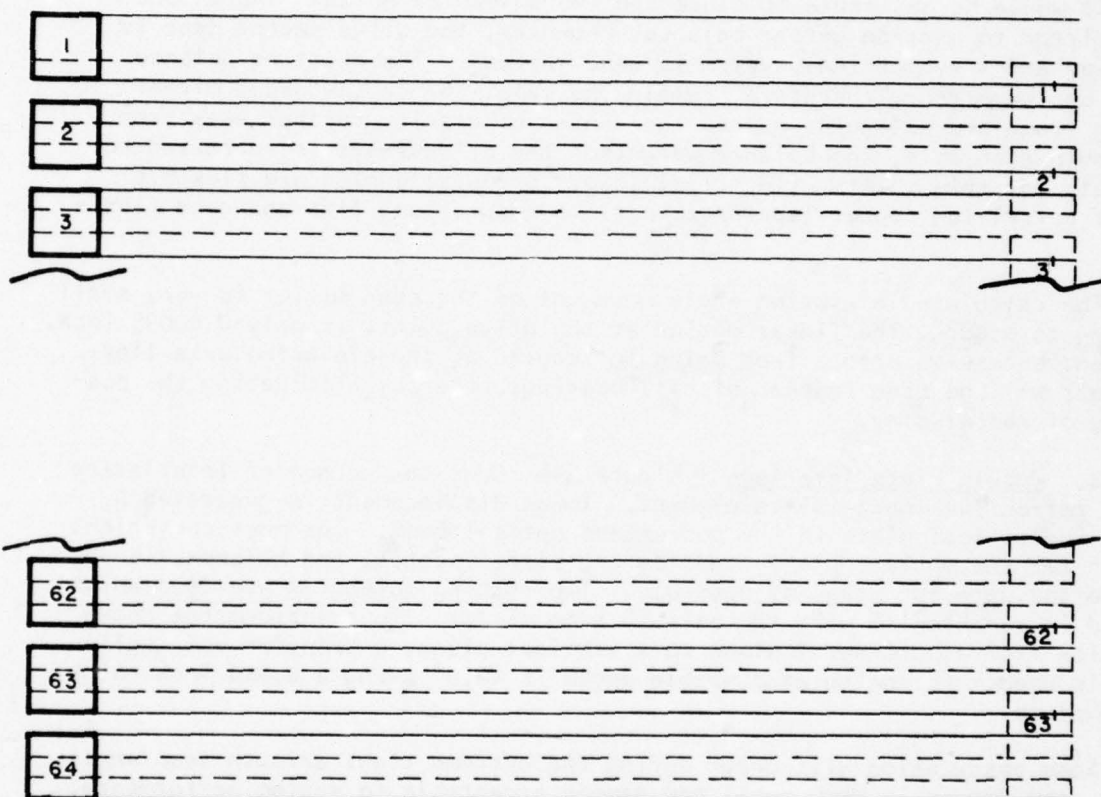
Figure 9-2. Interlace Scheme

It is possible by interlacing two successive scan fields to double the number of raster lines in the display (see Figure 9-2). This type of interlace will completely eliminate the 33 percent gap. The interlace will provide some overlap of scanned lines resulting in a more uniform display raster. The higher number of vertical sample points is expected to also improve the vertical MTF.

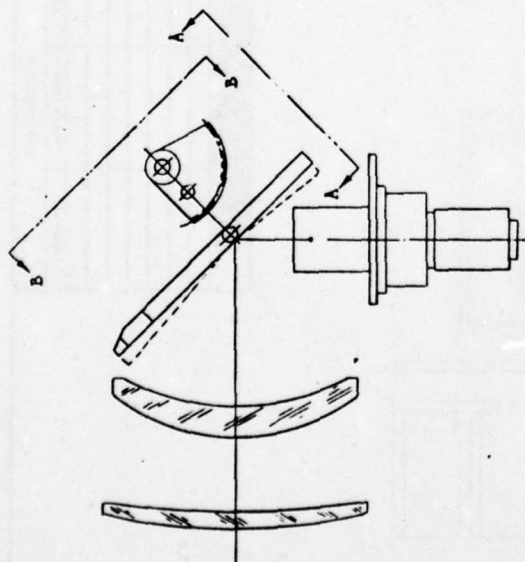
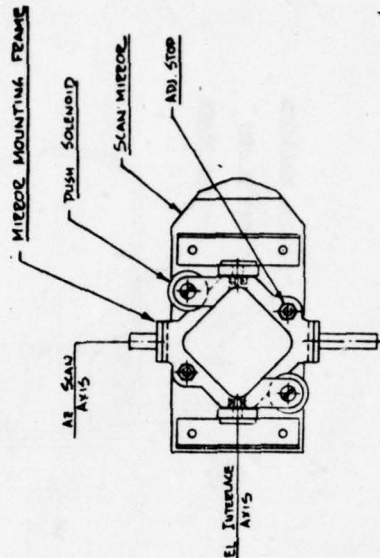
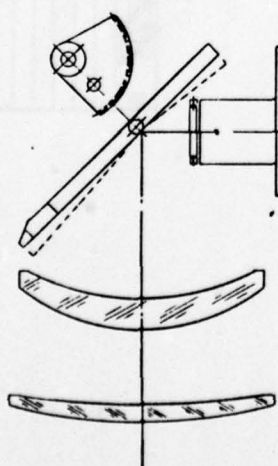
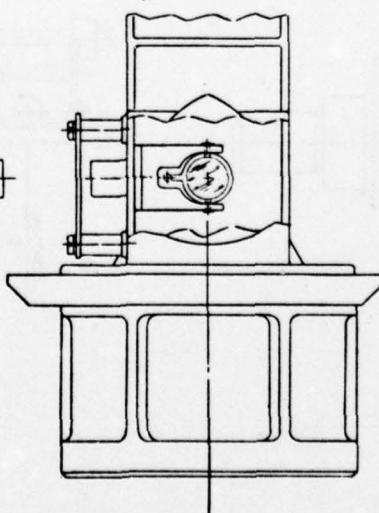
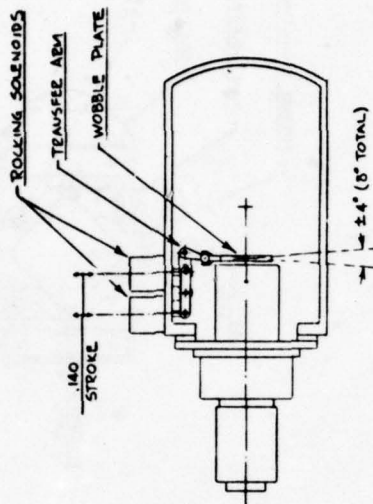
VIEW A-A

VIEW B-B

Most image improvement techniques discussed in paragraphs 9.3.1 through 9.3.3 have been successfully implemented in two imaging systems, the VANS and the TE cooled extended range version of the AN/TAS-3. A substantial degree of improvement has been achieved in reduced raster flicker, grey scale rendition and display homogeneity as well as improved MRT and MTF. These improvements have been realized without a major redesign effort and are readily adaptable to present AN/TAS-3 hardware.

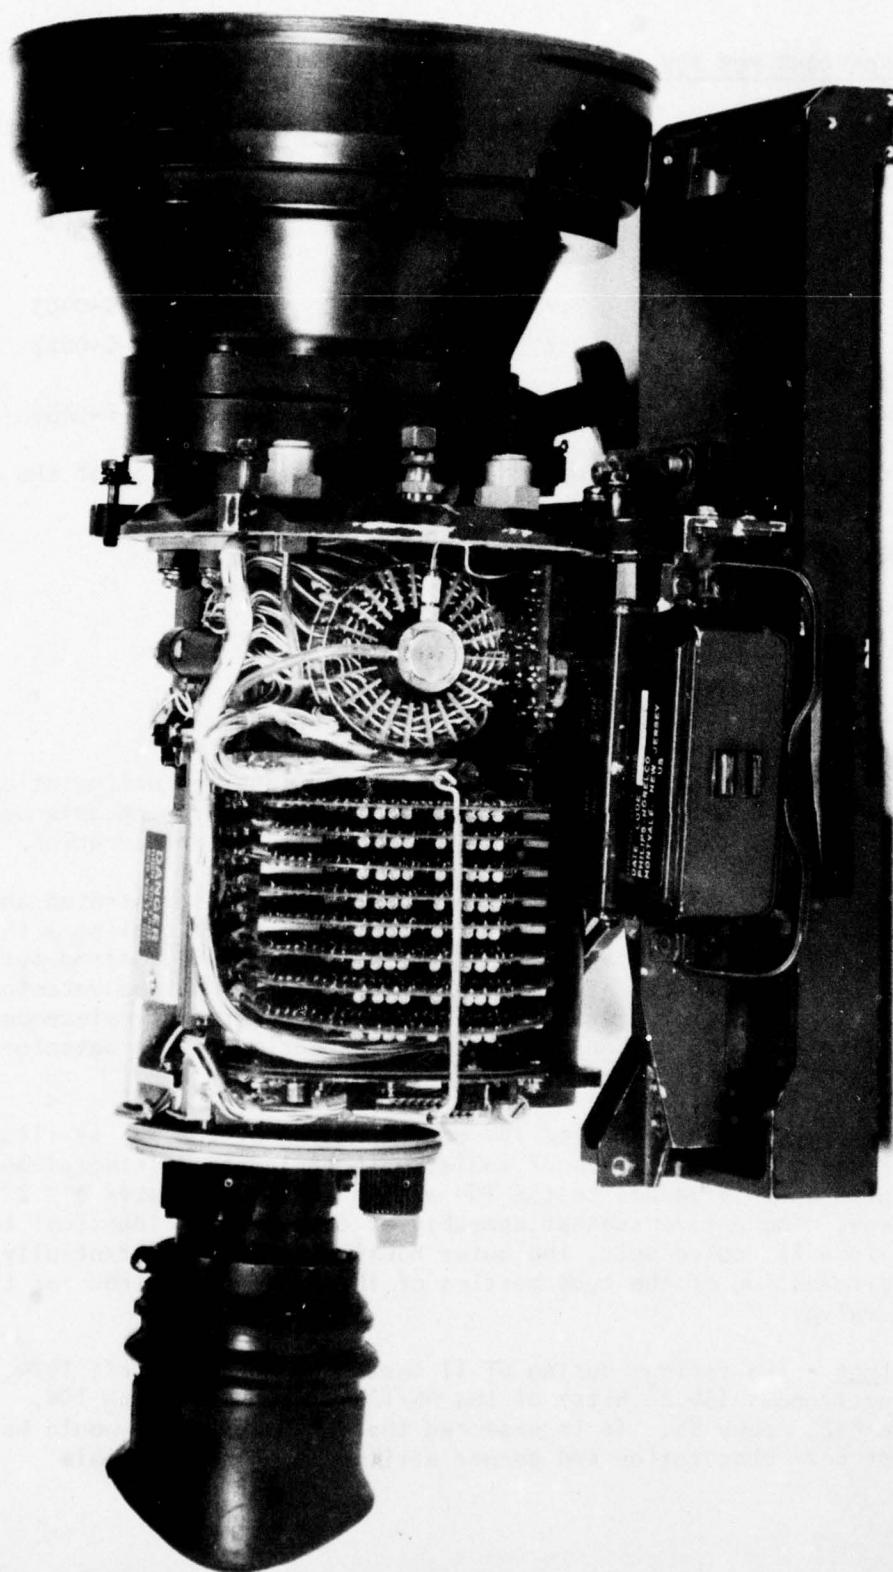
Figure 9-6. ER/NVS - J-T Cooled - TOW Configuration

TOW Configuration - A dedicated TOW configuration of the NVS is illustrated in Figures 9-6 and 9-7. This JT cooled unit includes an integral bore-sighting mechanism which attaches to the TOW weapon and incorporates a 7.2" focal length lens. The entire scanner assembly of this unit is identical to the AN/TAS-3. In a TE cooled unit, the outer housing will be substantially simplified by elimination of the tube portion of the housing required for the gas bottle and valve.
